Thank you for your kind enquiry and as requested our surveyor, *Surveyors Name*, visited the above property on Tuesday 17th November to carry out a damp inspection. We report and quote as follows:

The property is a semi-detached cottage, constructed of stone and rubble infill external walls, the roadside wall is rendered. The property has a slate roof, rendered chimney, PVC guttering, UPVC windows and solid concrete ground floors, with a modern damp proof membrane. At the time of the survey the property was occupied and furnished. The weather at the time of our inspection was rain with a temperature of approx. 11°C.

ADDRESS OF PROPERTY BEING TREATED

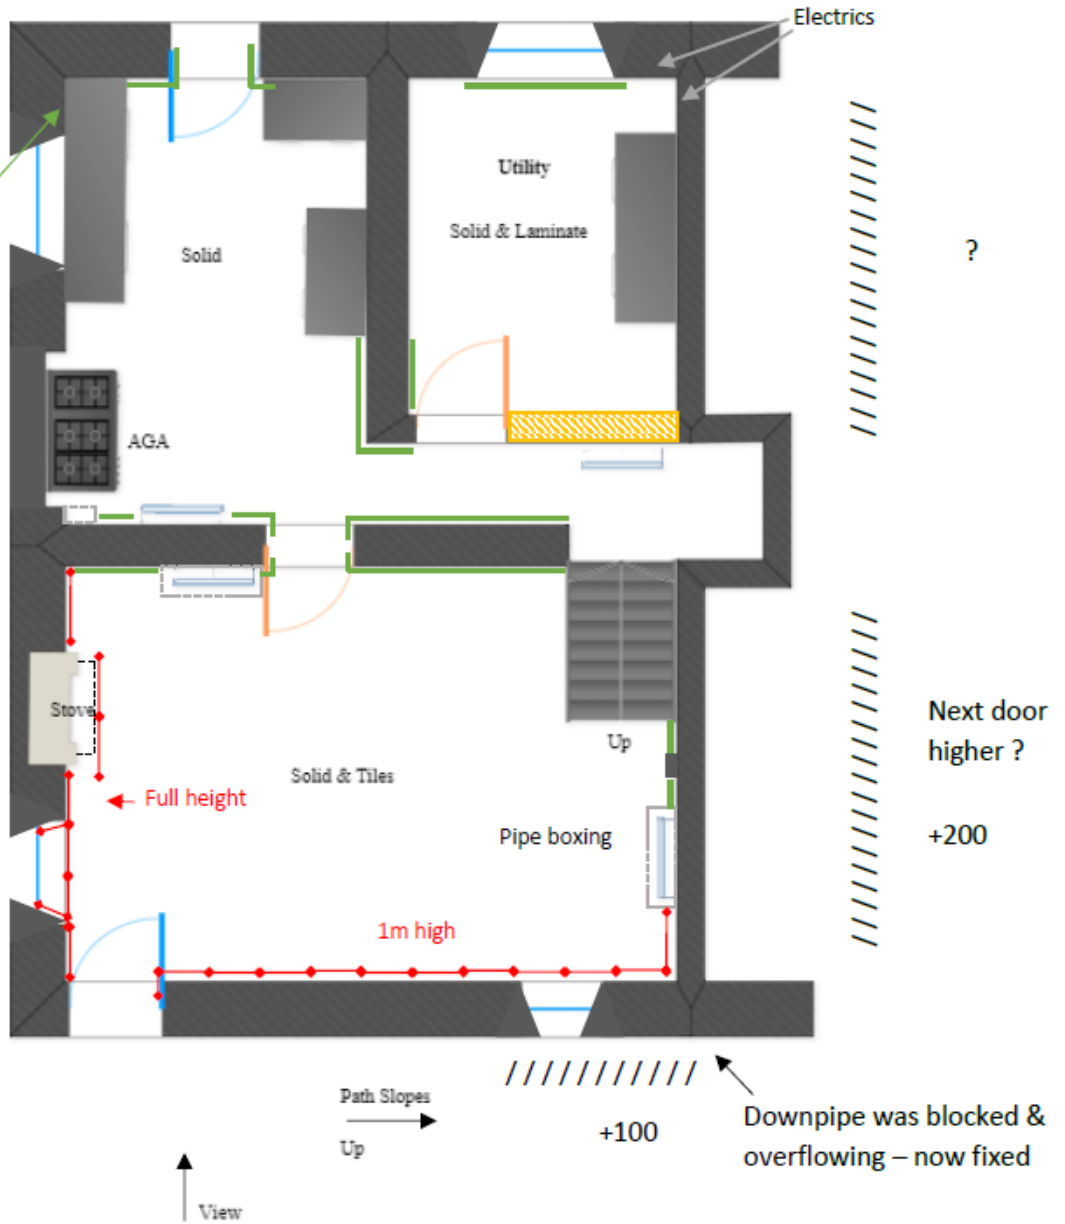
Green – High moisture readings – could be left & monitored, controlled with ventilation. Not causing problems at the moment.

Patch at higher level

WATERPROOF MEMBRANE
