**RE: *Property Address***

Thank you for your kind enquiry and as requested our surveyor, *Surveyors Name*, visited the above property on Monday 23rd November to carry out a damp inspection. We report and quote as follows:

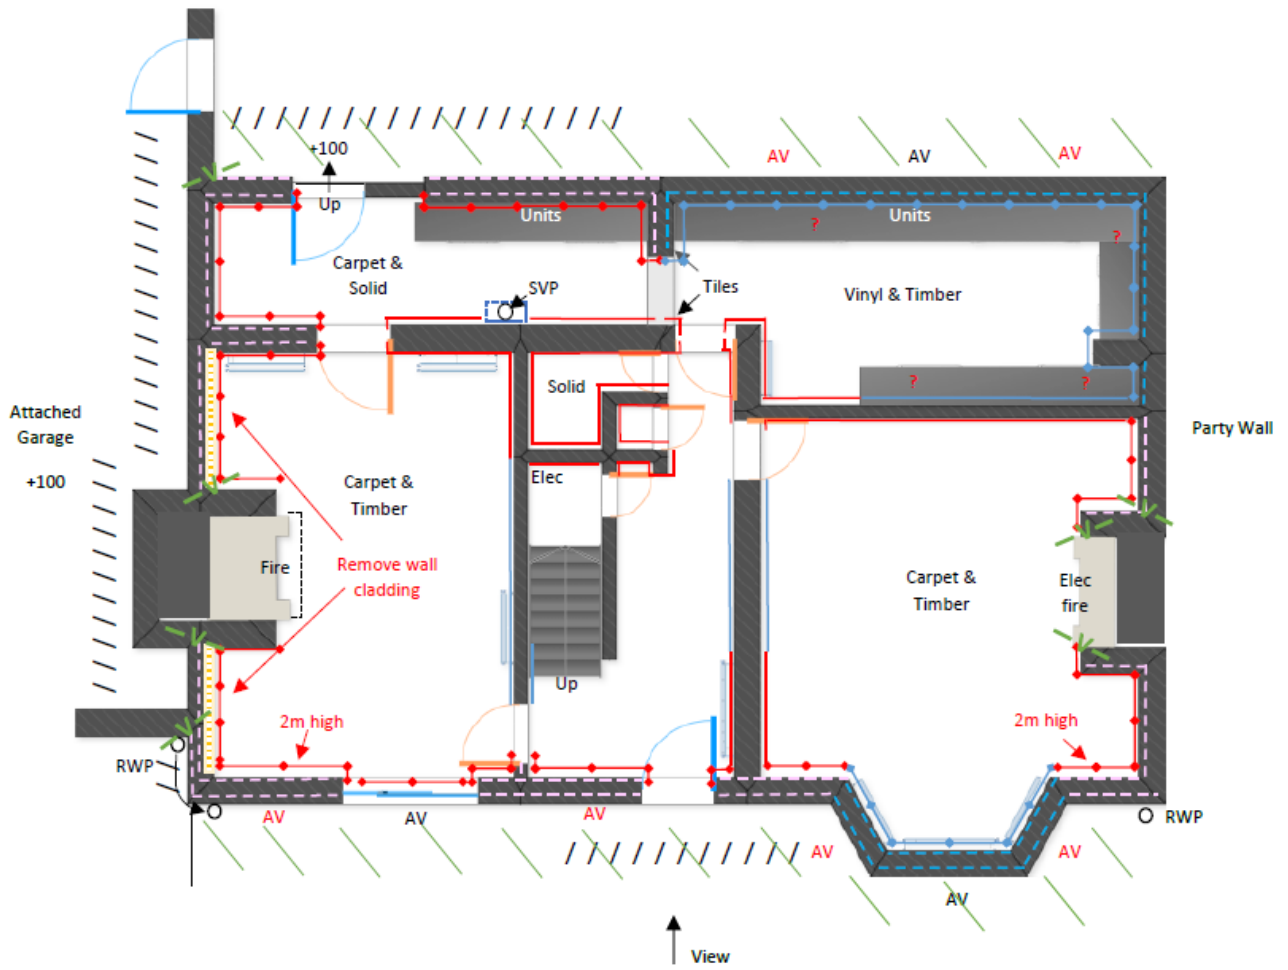
The survey was restricted to the area requested - the ground floor walls. Readings taken with the aid of an electrical conductivity type moisture meter (Protimeter) revealed evidence of rising and penetrating damp, and hygroscopic mineral salts to certain areas. See the sketch plan, some areas were inaccessible and are thought to be damp. Other walls tested dry but we have included them in the suggested treatments so as to provide a complete guarantee.

Some higher external levels were identified to the front and rear, also the garage floor is approximately 100mm higher than the house floor.

Areas confirmed as damp  
– shown in **RED**

Areas not seen which could be damp or  
suggest that treatments are extended  
to complete the works – shown in **BLUE**

External ground levels should be  
lowered similar to next doors –  
shown in diagonal **GREEN** lines

The timber wall cladding and existing skirting boards will be removed and disposed of, it is assumed that they will be renewed by others. We will hack off the wall plaster to the height of 1000/2000mm, to be removed from site for waste disposal. We will drill into the walls and inject a silicon cream damp proof course, as shown on enclosed sketch floor plan.

A waterproof wall membrane (as the manufacturers specification) will be applied to the external and party walls shown, and will be sealed at perimeters where necessary.

We will improve the ventilation to beneath the timber floors, installing 6 additional subfloor air vents.
